Manhole Inspection Summary

Manhole # S17M__017MH

Insp Date: **4/21/09 11:06 AM**

Location Address: **2401 FREDERICK AV**

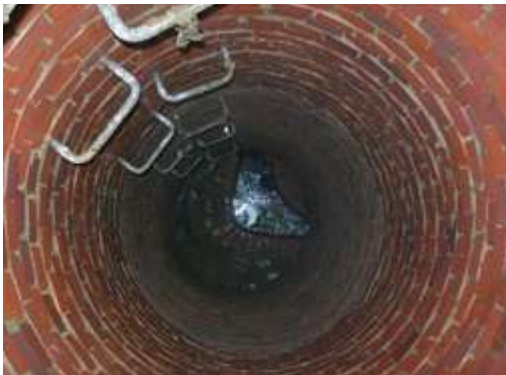
Defect 1

Bench ☒ Exists Material: **Brick** ☐ Parged
Condition: ☐ Sound ☐ Cracked ☐ Root Intrusion ☐ Deteriorated ☐ Leaks ☒ **Debris**

Surcharge ☒ **Evidence Of Surcharge** Depth: **0** (ft.) ☐ Active Surcharge Present

Surcharge Evidence; bench debris

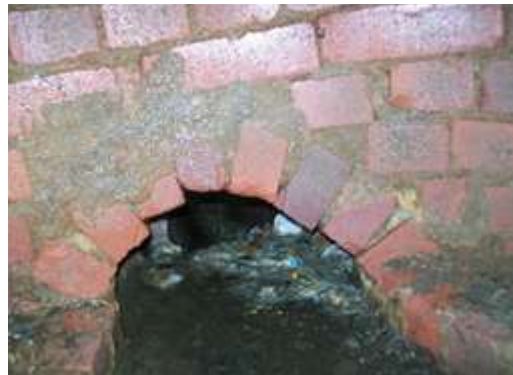
Defect 2

Channel Material: **Brick** ☐ Parged
Channel Exposure: **Fully Open** Junc Dist: **0** nearest .5 ft. Azimuth: **0**
Condition: ☐ Sound ☐ Cracked ☐ Root Intrusion ☐ Deteriorated ☐ Leaks ☒ **Debris**

channel debris

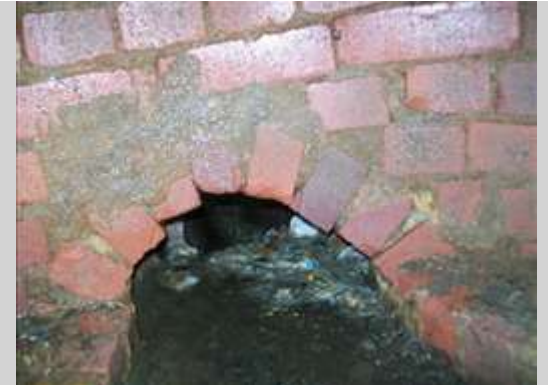
12 O'Clock Outflow

8 in. Circular Gravity Sewer
Pipe Out @ 12 O'Clock

Pipe Height: **3.6** (in.) Rod and Bar (Angled)
Pipe Material: **Clay** ☐ Pipe Lined
Invert Depth: **0.00** (ft.) Flow Characteristics: **Slow**
Deposits: ☐ None ☒ Mud ☒ ~~Gravy~~ ☒ Debris ☐ Grease
Silt Depth: **4** (in.) Deposits Extent: **Heavy**
Infiltration: **None** Pipe Seal Cond: **Sound**

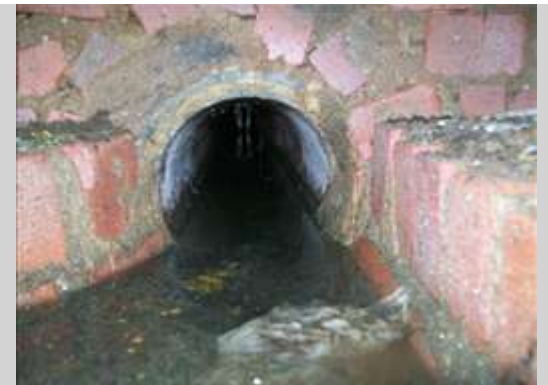
3 O'Clock Inflow

8 in. Circular Gravity Sewer
Pipe In @ 3 O'Clock

Pipe Height: **3.6** (in.) Rod and Bar (Angled)
Pipe Material: **Clay** ☐ Pipe Lined
Invert Depth: **0.00** (ft.) Flow Characteristics: **Slow**
Deposits: ☐ None ☐ Mud ☒ ~~Gravy~~ ☐ Debris ☐ Grease
Silt Depth: **1** (in.) Deposits Extent: **Light**
Infiltration: **None** Pipe Seal Cond: **Sound**
